**UM-3732-98
1998 Oldsmobile Intrigue**

**In-depth
Vehicle
Occupant
Report**

The University
of Michigan
Transportation
Research Institute

Case Vehicle (A): 1998 Oldsmobile
 Type: Intrigue, 4-door sedan
 Driver: 38-year-old female
 CDC: 01-FDEW-2

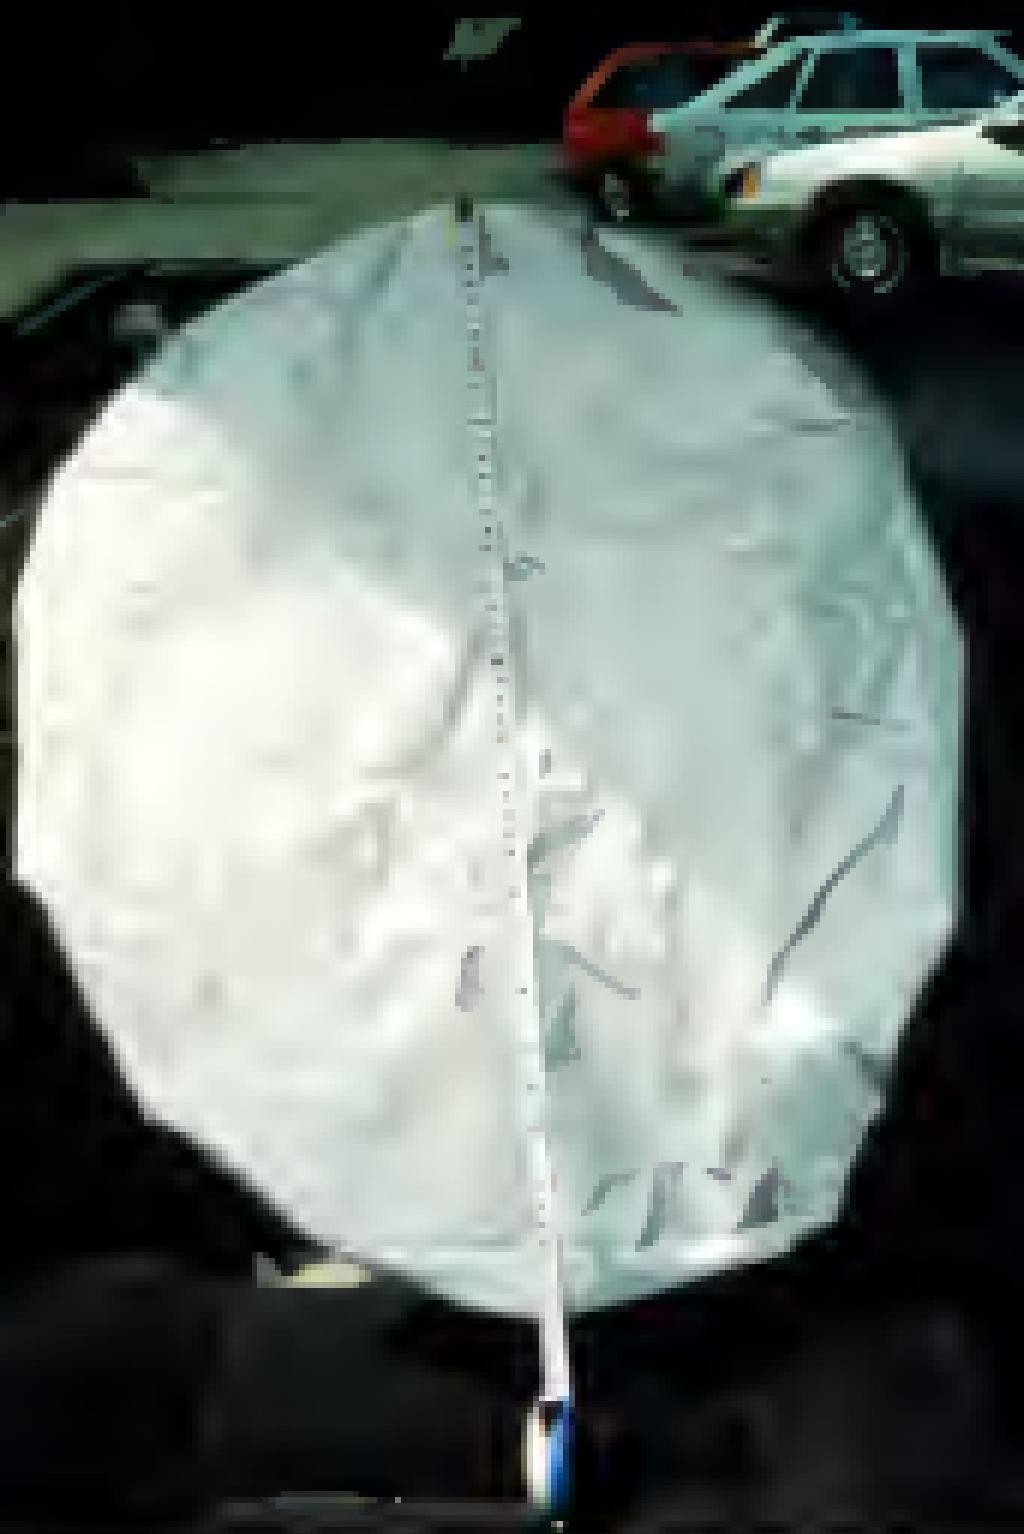
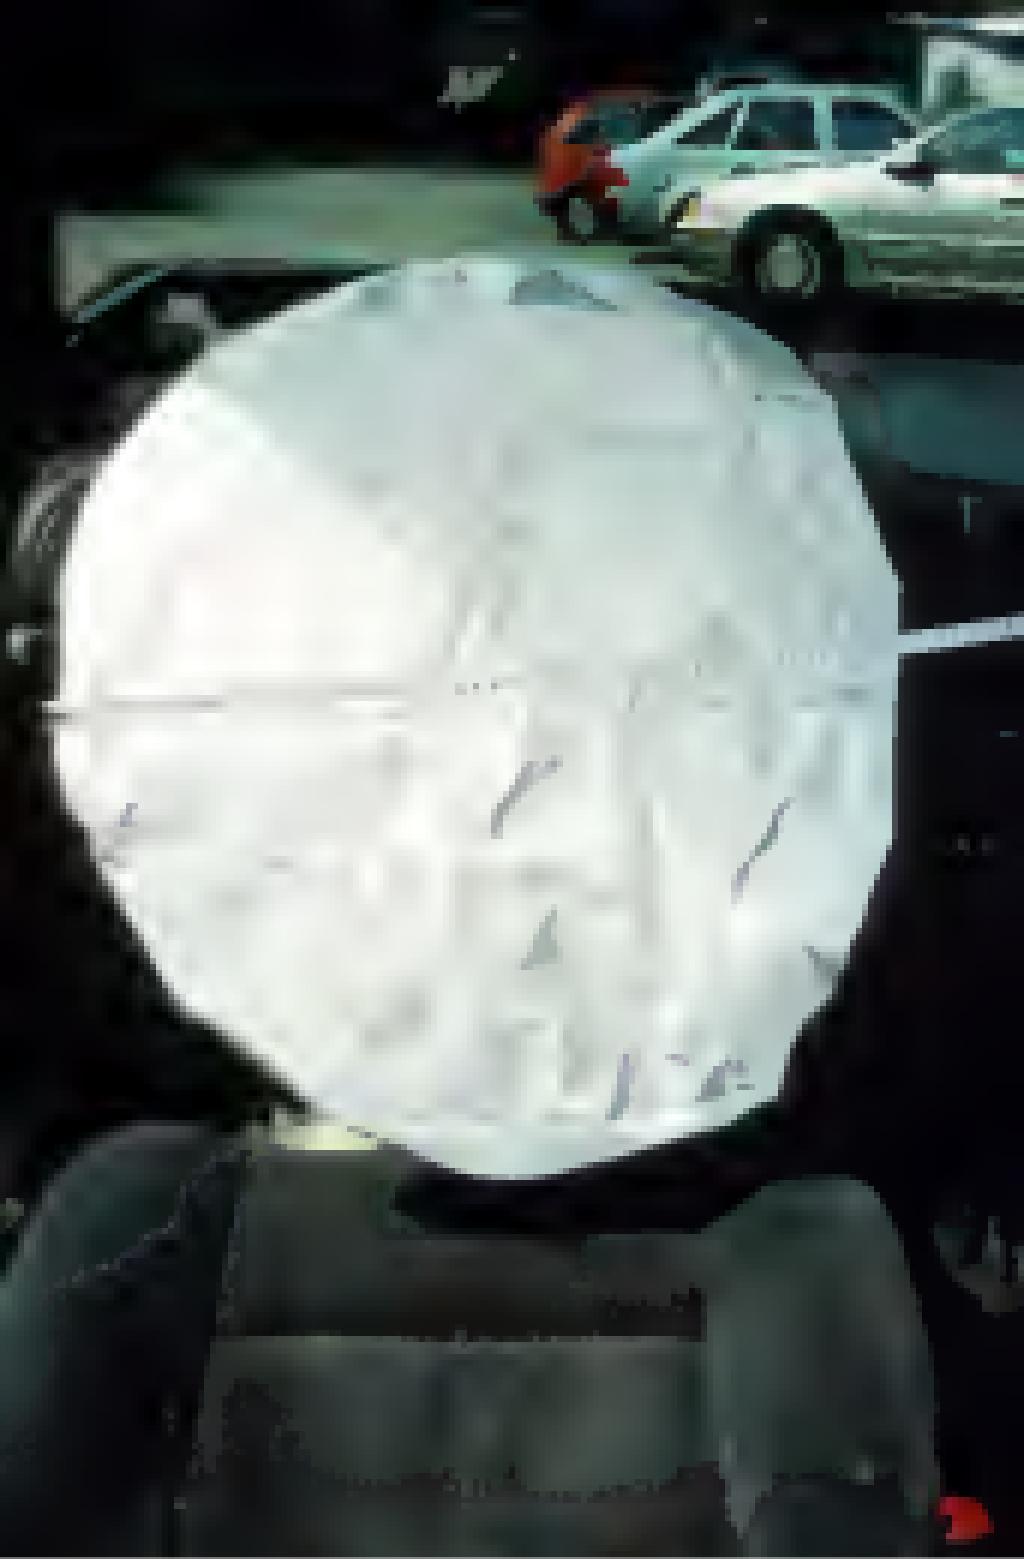
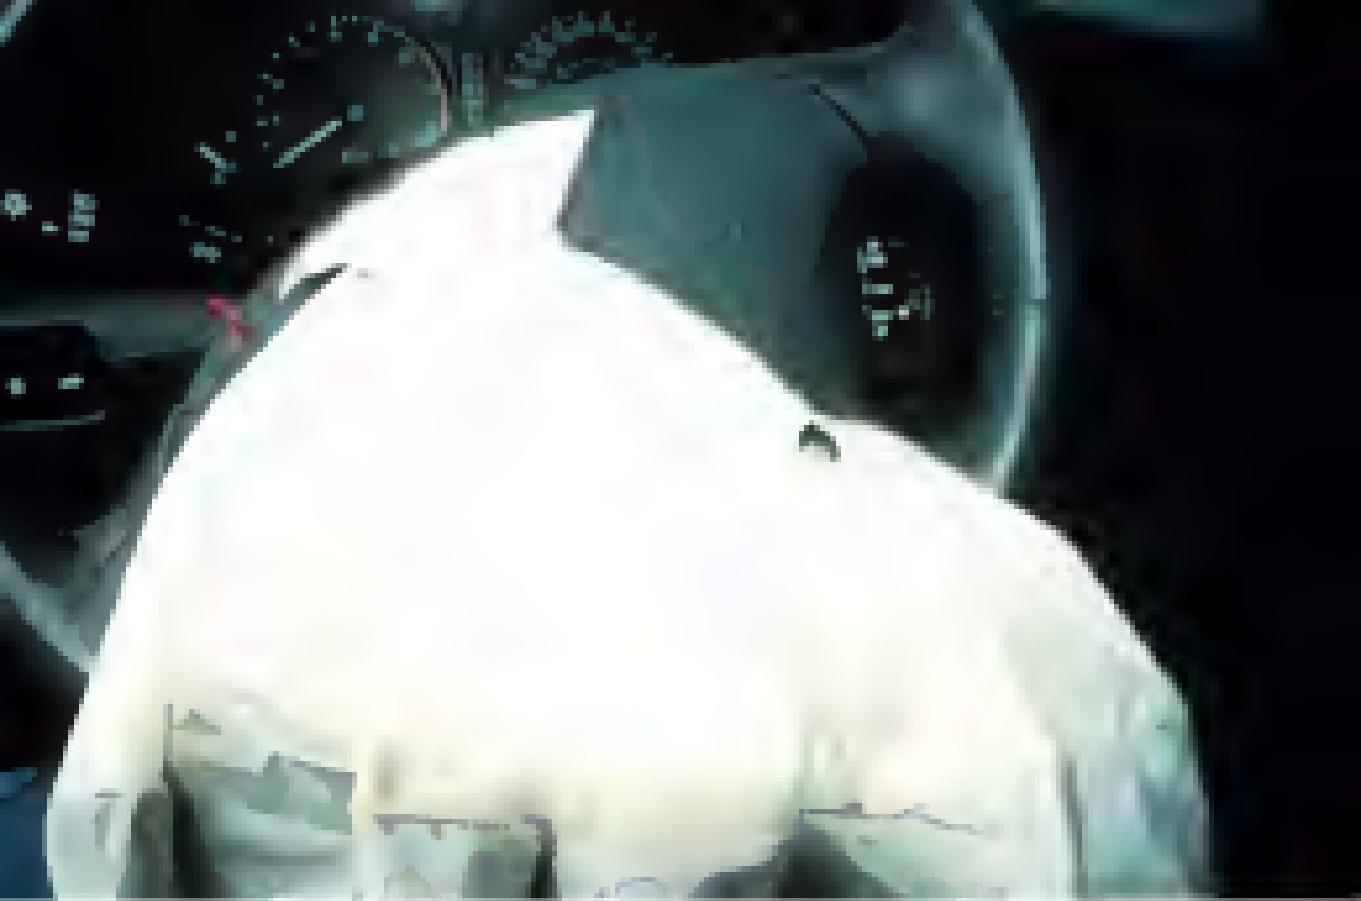
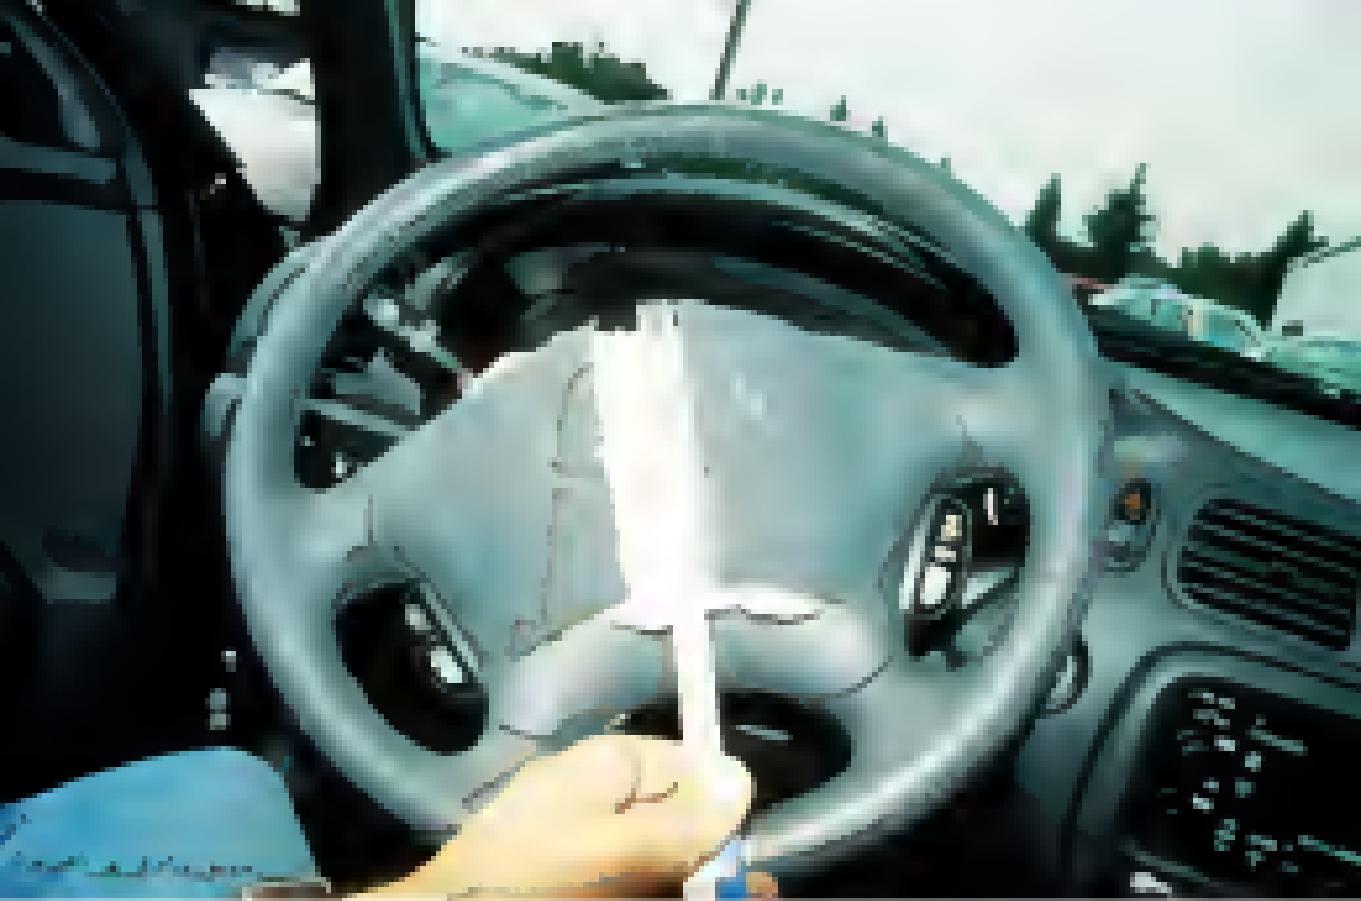
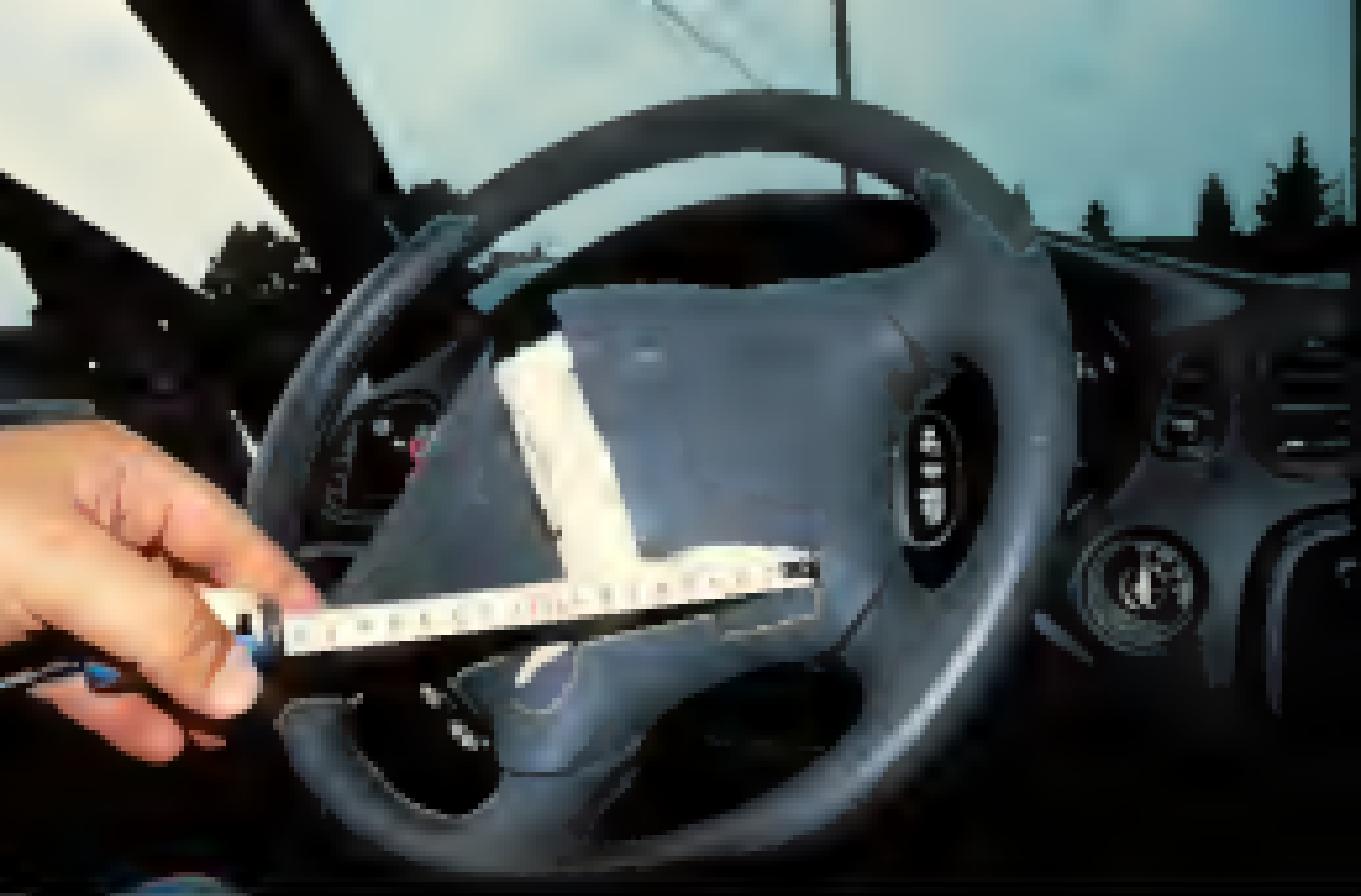
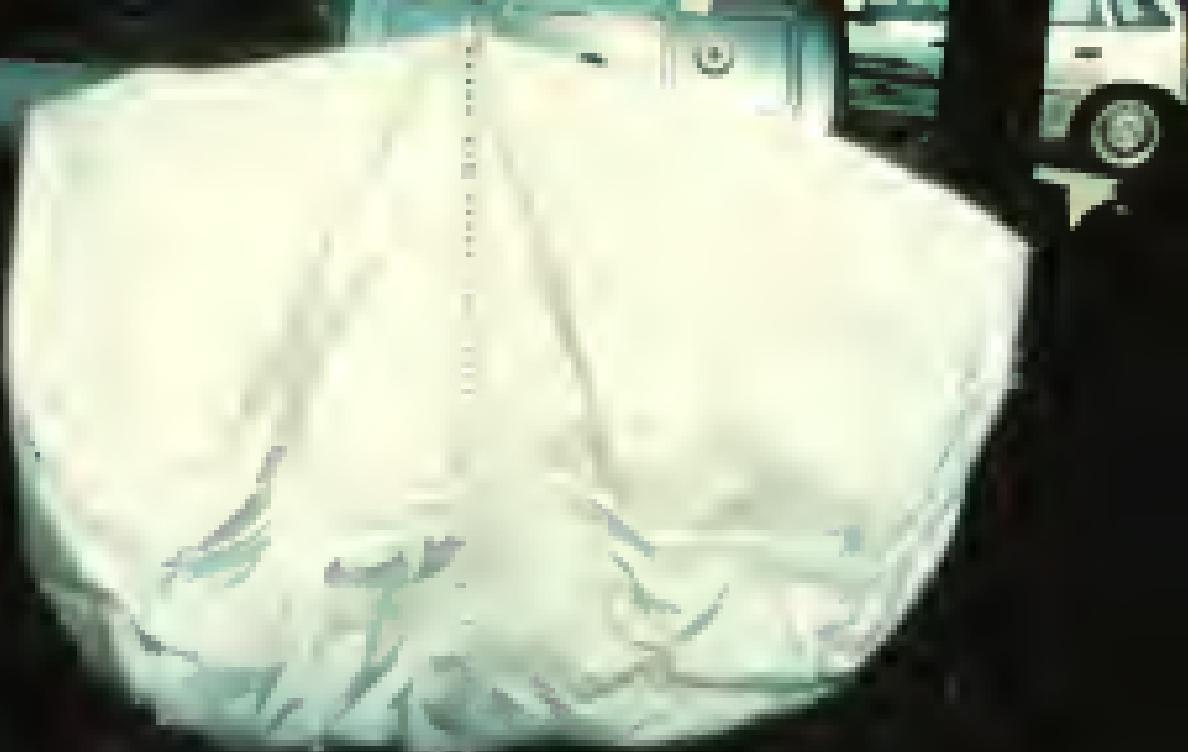
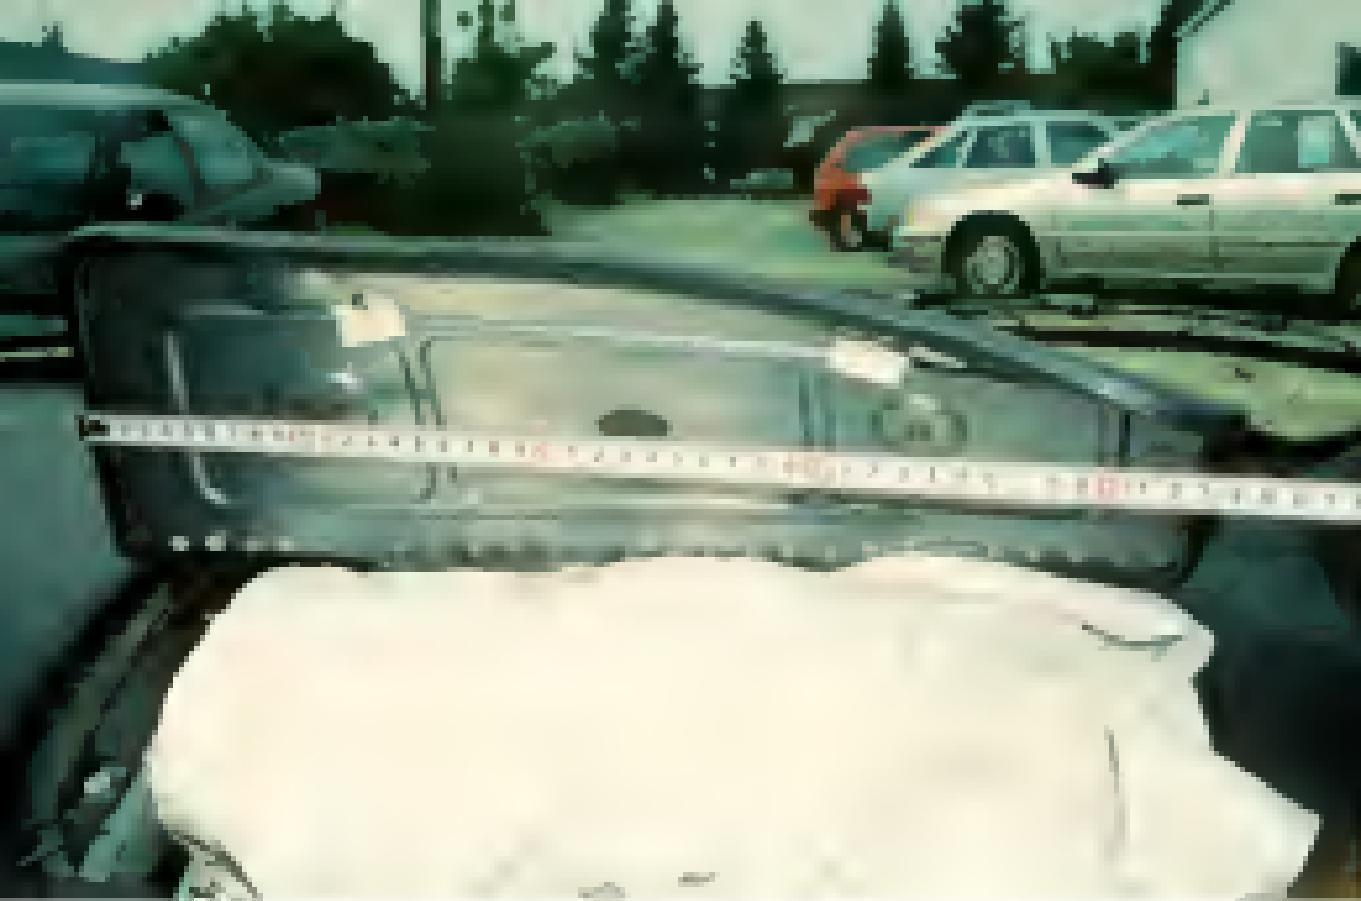
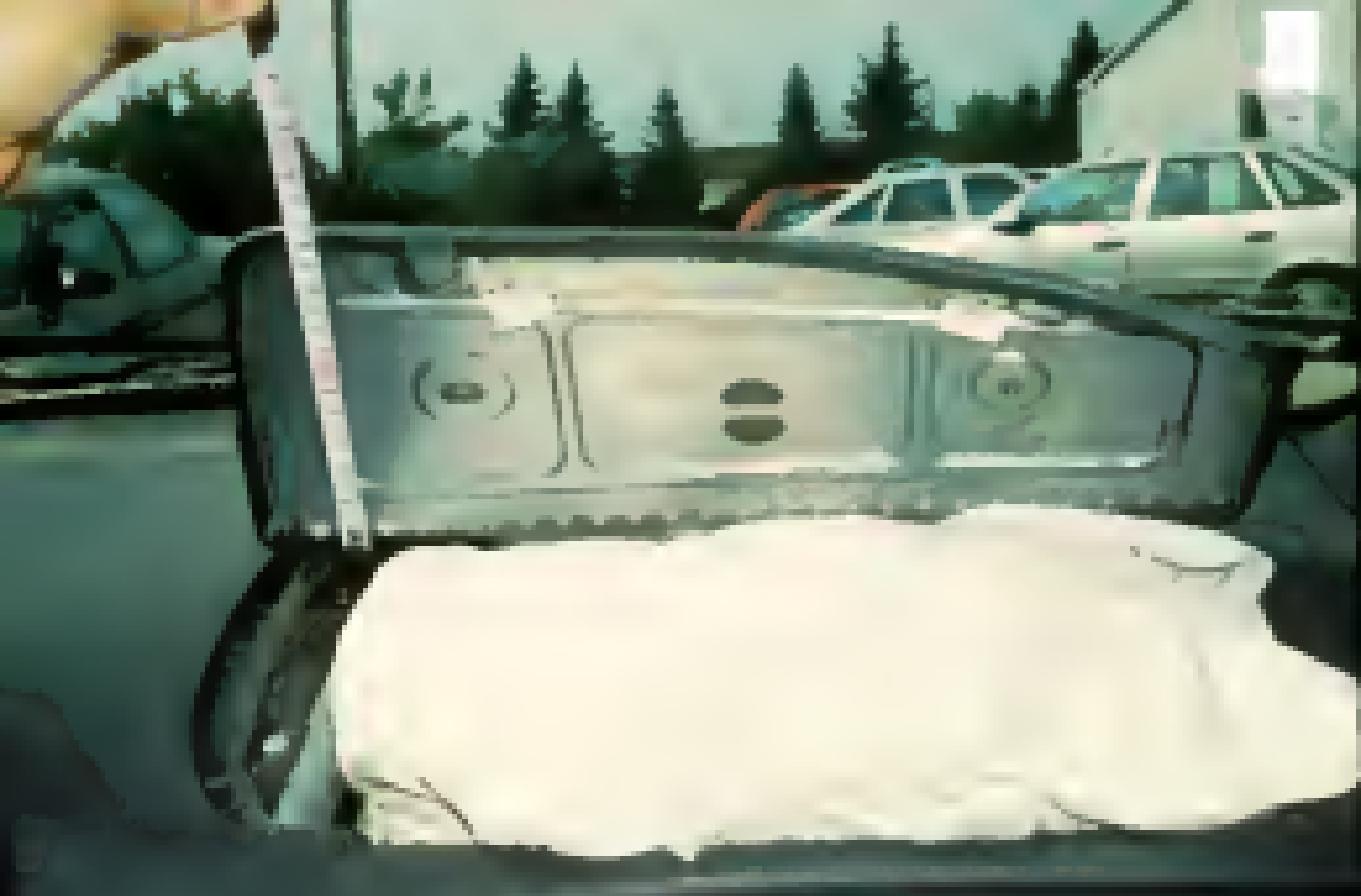
(Slides 15, 16, 17, 18, 19, 20, 21, 22, 23) This vehicle was equipped with steering-wheel and passenger frontal-impact airbags, which deployed during the frontal impact. No damage was noted to the airbag skins or their module doors/flaps. (Slide 24) The steering-wheel rim and spokes were not damaged. No intrusions were noted. (Slides 25, 26, 27, 28, 29) Damage to the interior of the vehicle was limited to that caused by the deploying airbags.
